**SECOND PERIODIC REVIEW  
(DRAFT)**

**GENERAL ELECTRIC SPOKANE SITE  
SPOKANE, WA**

**MARCH 2008**

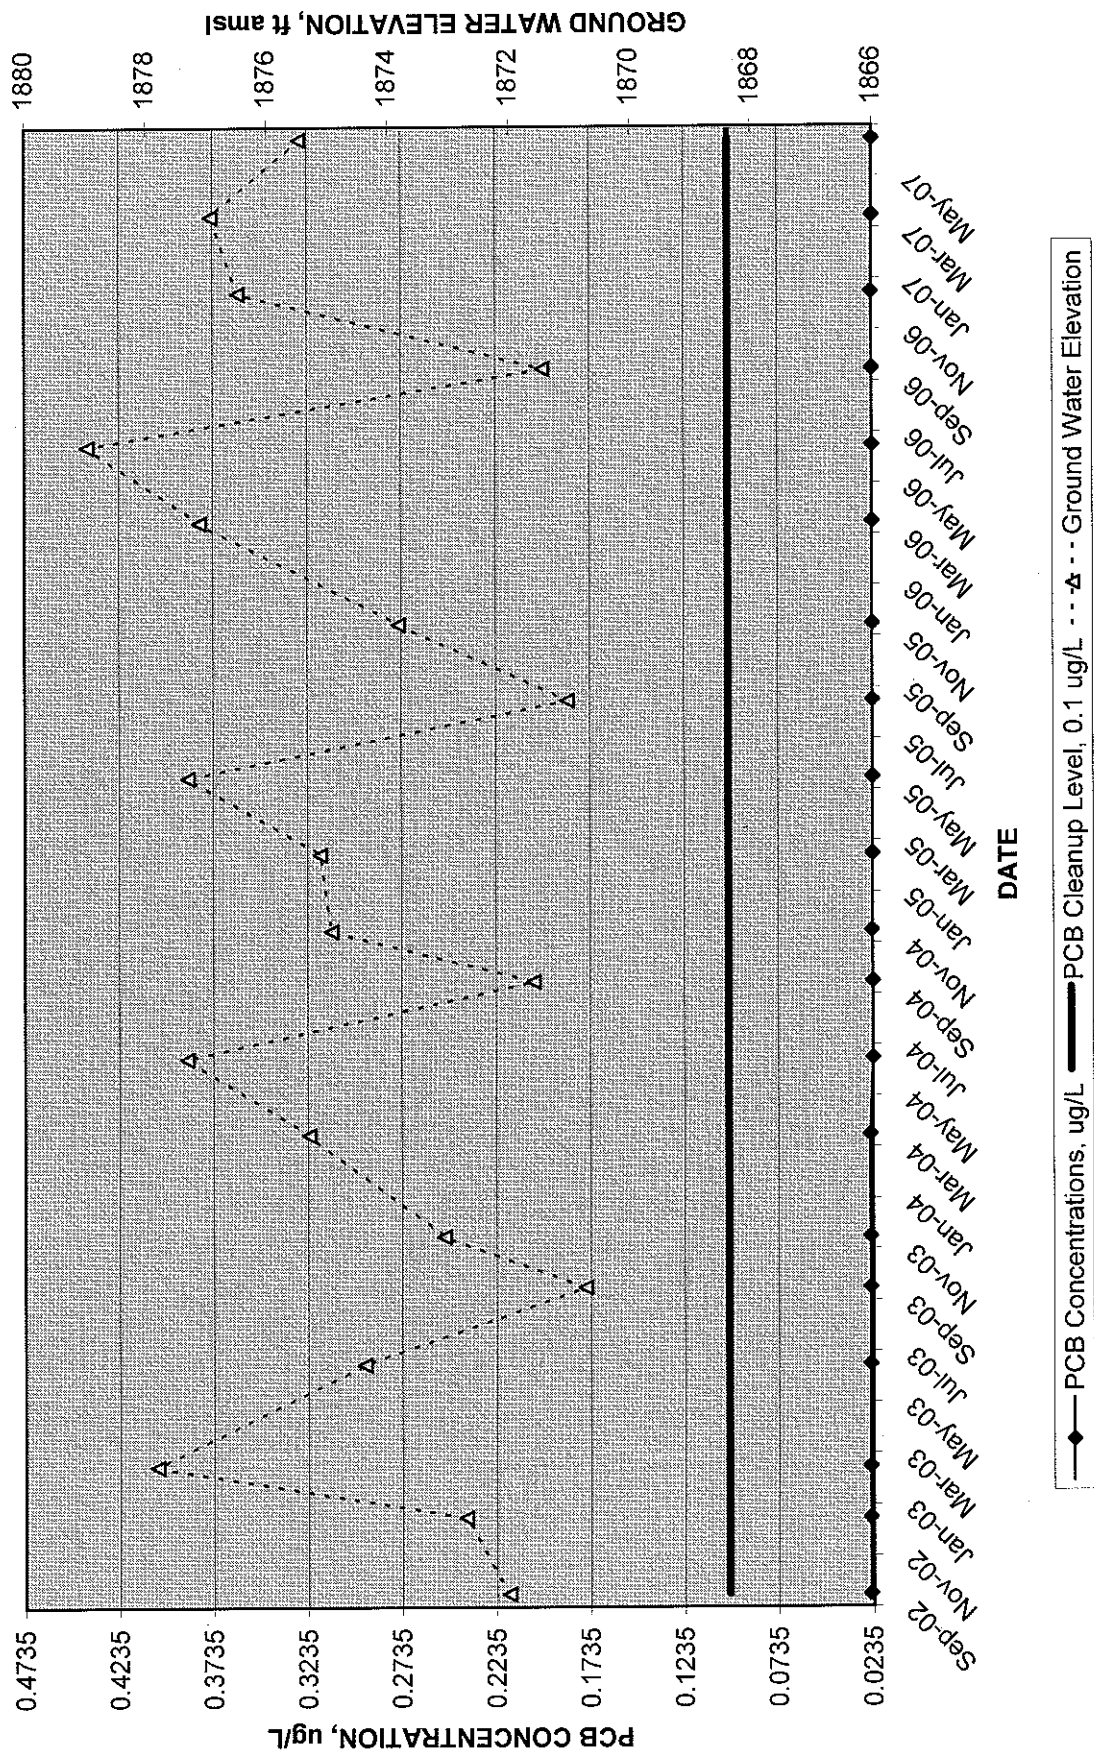
FIGURE 10. MW11 PCB CONCENTRATIONS AND GROUND WATER ELEVATIONS

This is the only well that consistently showed PCB concentrations above the cleanup level. PCB concentrations appear to be strongly correlated to ground water elevations with the maximum PCB concentrations for each year occurring during or slightly following the highest ground water elevations. Observed maximum concentrations for each year have been decreasing even though ground water elevations have been increasing. PCB concentrations during this review period exhibit a decreasing trend despite increasing ground water elevations.

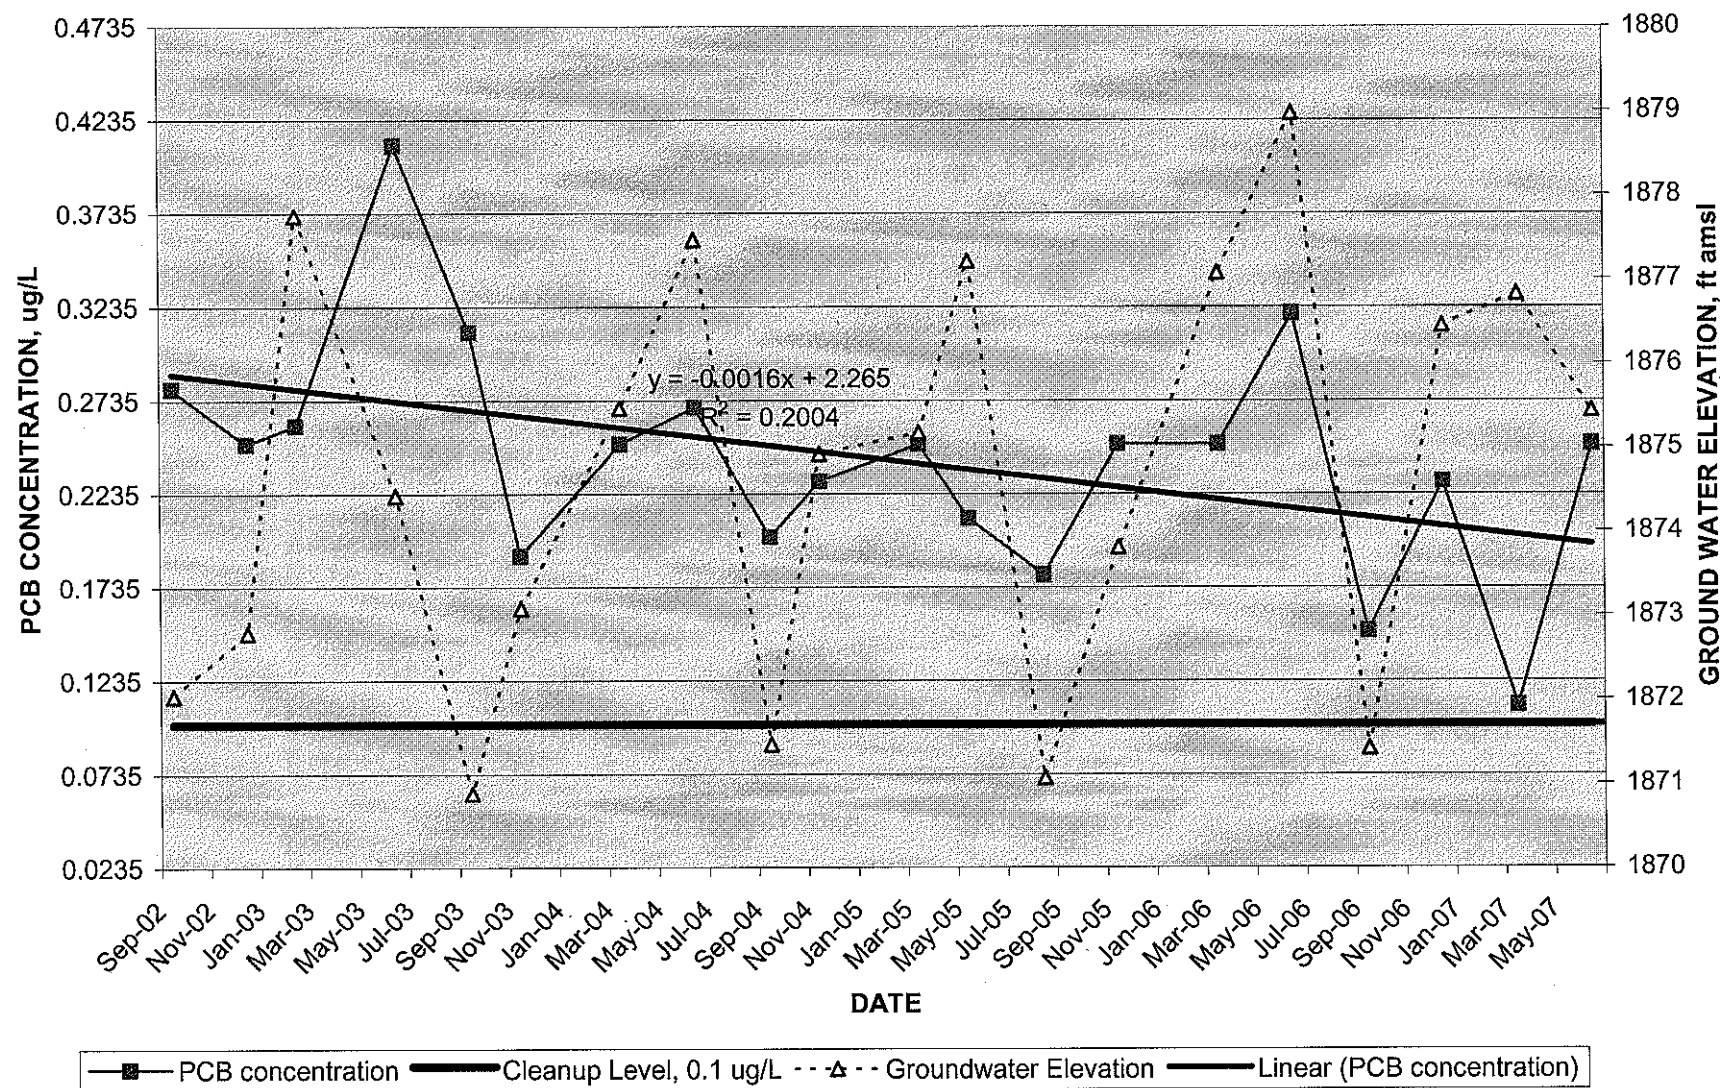
FIGURE 11. MW18 PCB CONCENTRATIONS AND GROUND WATER ELEVATIONS

PCB detections were all below the cleanup level. Higher detections occurred following high ground water elevation periods.

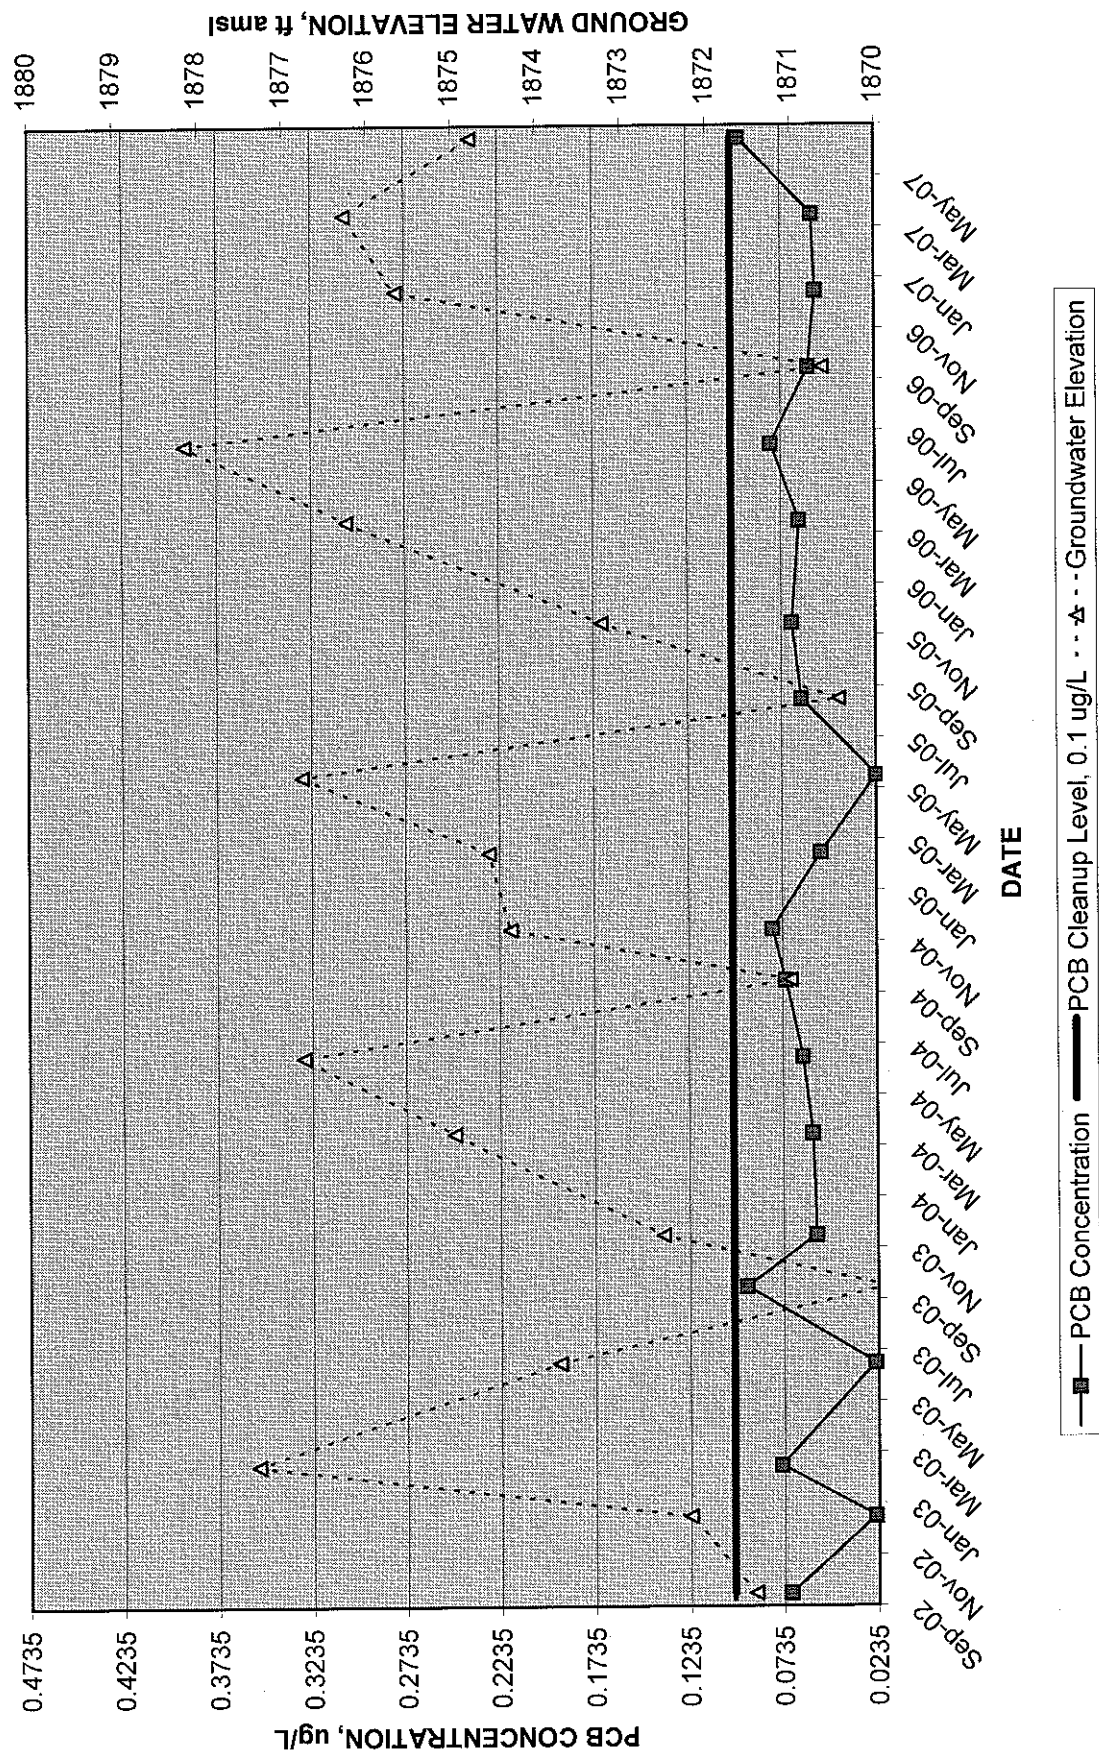
FIGURE 12. MW22 PCB CONCENTRATIONS AND GROUND WATER ELEVATIONS

This is the monitoring well that is closest to the Spokane River. PCB concentrations throughout this review period were nondetects except for one that is below the cleanup level observed in June 2003.
